National Register of Historic Places Registration Form

OF. MICHAEL'S CATHOLIC
CHURCH COMPLEX (NEMBO #PTI2-14436)
TARNOV, PLATTE COUNTY, NEBRASKA WITE PLAN-NO SCALE

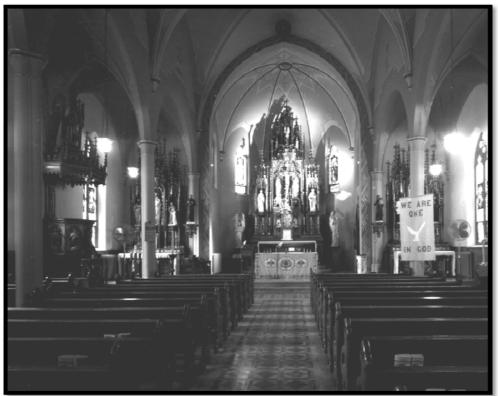
Photo 3 of 9 Looking W toward altar Photo by D. Murphy, July 1980, NSHS (DM8007-38)

The interior plan consists of a nave, chancel, sacristy area, vestibule, balcony and a baptism area. The interior with its high vaulted ceiling combined with brilliant color from the stained glass windows gives it a spirit of reverence and solace. The seating capacity is for 350 people.

Within the chancel area is an altar more than 27 ft. tall with a 4 ft. x 10 ft. base constructed in Europe of cherry wood of Gothic design. The hand carved finials and crochets decorate The decorative carvings are painted in the many tall spires. gold leaf. In the base front, a sculptured picture of the Last Supper is set in. It is also adorned with a large crucifixion scene and numerous Saints' statues. The ceiling of the chancel area is 30 ft. high made of 5 ribs to form the vault. altar is set on a platform three steps from floor to nave. Altars of the Blessed Virgin and Joseph are located on either side of the chancel area. They are two steps from the main They match the Gothic design of the main altar. from the chancel ceiling is a beautiful large gold plated eternal sanctuary light. Gargoyles surround the base to represent the devil. Many colorful stones encircle the lamp. A candle always burns in it.

Two nave arcades of five capitols each seem to lead the march to the high altar. The capitals are of the Doric design. Fluted boards which are painted were added for the finished look. Two steel posts support the balcony. The high 36 ft. nave ceiling is made up of quadripartite rectangular vaults with a pair of transverse ribs and a pair of wall ribs. The two side isle ceilings are likewise constructed.

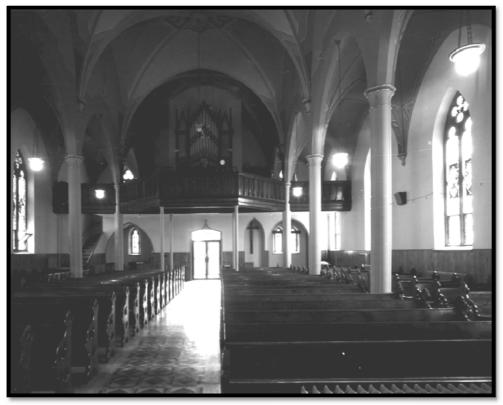
Photo 4 of 9 Looking E toward balcony Photo by D. Murphy, July 1980, NSHS (DM8007-37)

There is a large choir loft. The pipes from the original organ are still there. They range in size from 10 ft. to 12 ft. with various size diameters. It has a seating capacity of 50 people. A Gothic style wooden bannister surrounds the loft.

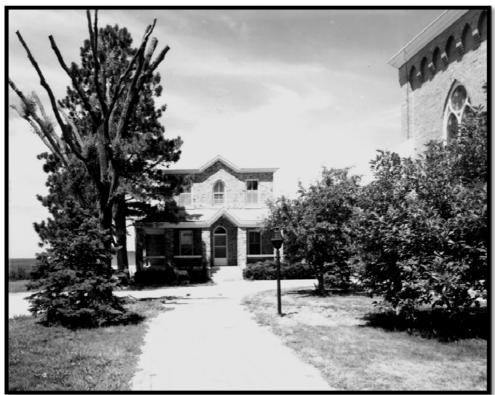
Photo 5 of 9 Looking W showing E (front) façade of rectory Photo by D. Murphy, July 1980, NSHS (DM8007-34)

St. Michael's Rectory was constructed in 1911. story, ten room, brick rectangular house is 36 ft. x 40 ft. A 13" brick composite masonary frame forms the 20 ft. walls. The gray pressed fired brick, to match the church, is laid in American bond style with raked mortared joints. The normal hipped, pitched roof is covered with asphalt shingles. A chimney is in the center of the roof apex. The four pane, double hung windows are set in a symmetrical order. On the second floor on the east facade is a single hung window with a fan light window over it. The exterior window sills are of Bedford stone. The porticoe wraps around the east and south facade. The porticoe is supported by eight, 1 ft. square brick columns. The floor is of concrete. A triangular pediment is on the East facade porticoe over the main door entrance. Directly above this in the roof is another pediment. A semi circular fan light window is over the front door entrance. It does not have any architrave trim. shallow, molded, unadorned cornice completes the wall. A red wood deck was added on the west side entrance in 1966. A two car garage was added to the north side at the same time.

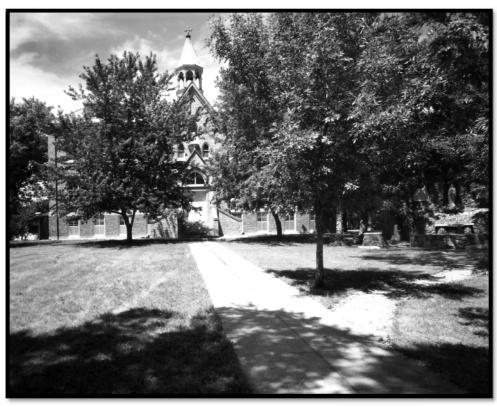
Photo 6 of 9 Looking W showing E (front) of school-convent & grotto Photo by D. Murphy, July 1980, NSHS (DM8007-33)

The base and foundation are constructed of rock and concrete 4 ft. wide and 5 ft. deep with a concrete floor under the whole structure.

The wall around the back is built in a half circle shape which measures 42 ft. around the bottom. The back wall is 14 ft. tall at the center gradually sloping down to 2 ft. at each end. At the center, the wall is 3 ft. thick narrowing to 30" at each end. The sides of the wall represent a mountain to more closely resemble the location at Lourdes, France.

The wall is built of irregular sand stone from Minnesota. The greater part of the grotto is of tuffa rock obtained from a cave in Kentucky set on the foundation.

St. Michael's Catholic School-Convent was constructed in 1910-1911. The three story brick building measures 48 ft. x 126 ft. with projections measuring 36 ft. x 35 ft, 24 ft. x 20 ft. and 20 ft. x 35 ft. A 16" composite masonry brick frame forms the 32 ft. high walls. Pilasters are on the corners and sides of the building for greater support. The fired, gray-pressed brick is laid in American bond style with raked mortared points. The steep gabled roof is covered with the original slate shingles. There are many hipped dormers placed throughout the roof. A cupola with six pointed open arches, a steep roof, is on the east facade. A school bell was in this cupola. Corbels decorate the

triangular pediment centered on the roof of the east front facade. The 8 ft. x 8 ft. main entrance has three separate openings with a triangle pediment of Bedford stone over the main door with a painted window completing the pediment. Around the main door is an architrave trim of Bedford stone. The composite masonry 18" brick foundation is half above and half under ground, it is topped with Bedford stone 12" high and 18" wide on which the walls rest. On the second floor east front facade are two pointed windows with two row lock arches over them. A niche between the windows held a statue of St. Michael which has been removed (see Item #2).

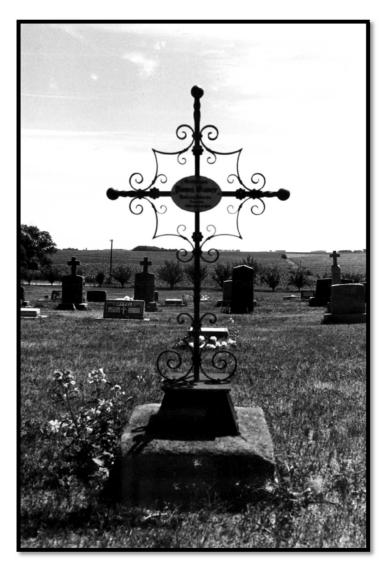
Photo 9 of 9 Looking E showing cemetery Photo by Jim Fagler, July 1980, NSHS (8007/8:32)

The cemetery lies to the north of the church. It is bordered on the north and west with scotch pines and the east by flowering crab apple trees. In the center of the cemetery is a crucifixion group. The statuary group consists of a crucified Savior on a 12 ft. high cross raised on a rectangular base of glazed brick on which are the figures of the Blessed Virgin Mary and St. John. Both of which are standing at the foot of the cross, Mary Magdalene is kneeling. Figures of angels with trumpets are on pedestals on each side of the main group. overall size of the group measures 12 ft. $x = 5 \frac{1}{2}$ ft. former Franciscan Pastors are buried near the crucifixion group. The cemetery contains several iron crosses dating from 1902 and The earlier grave markers have the names and dates written The cemetery was plotted in 1880 when the first in Polish. church was built. 1883 was the first burial recorded.
